7 Site Management: Cleaning and Reconstruction of the Balustrade around the Naos of Petosiris (GB 50) – Some Observations

7.1 *The balustrade*

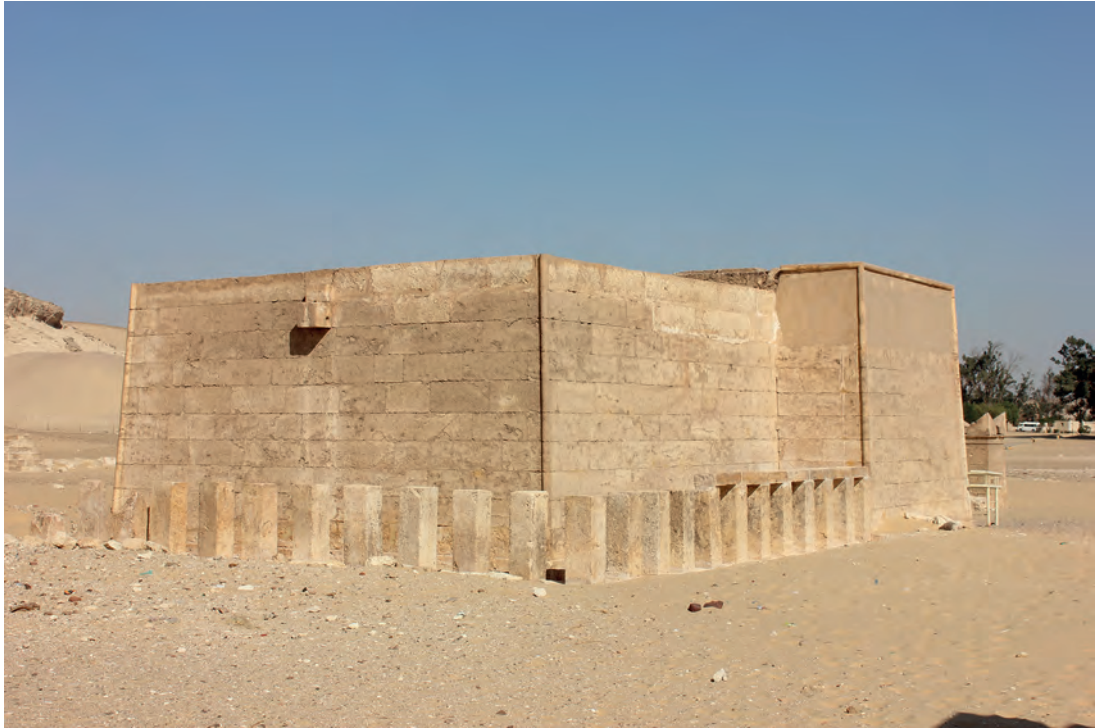
Fig. 1: The re-erected balustrade on the eastern and southern side of the tomb of Petosiris (GB 50); 2015

During the field school for restorers in October 2015¹ the area around the tomb of Petosiris (GB 50) was cleaned from sand in order to reconstruct the balustrade surrounding the rear part of the tomb (fig. 1). On the southern side most of the blocks were lying almost in their original position, while on the eastern side some of the upright pillars remained standing still in situ, but all of the horizontal slabs placed on top of them were collapsed. On the

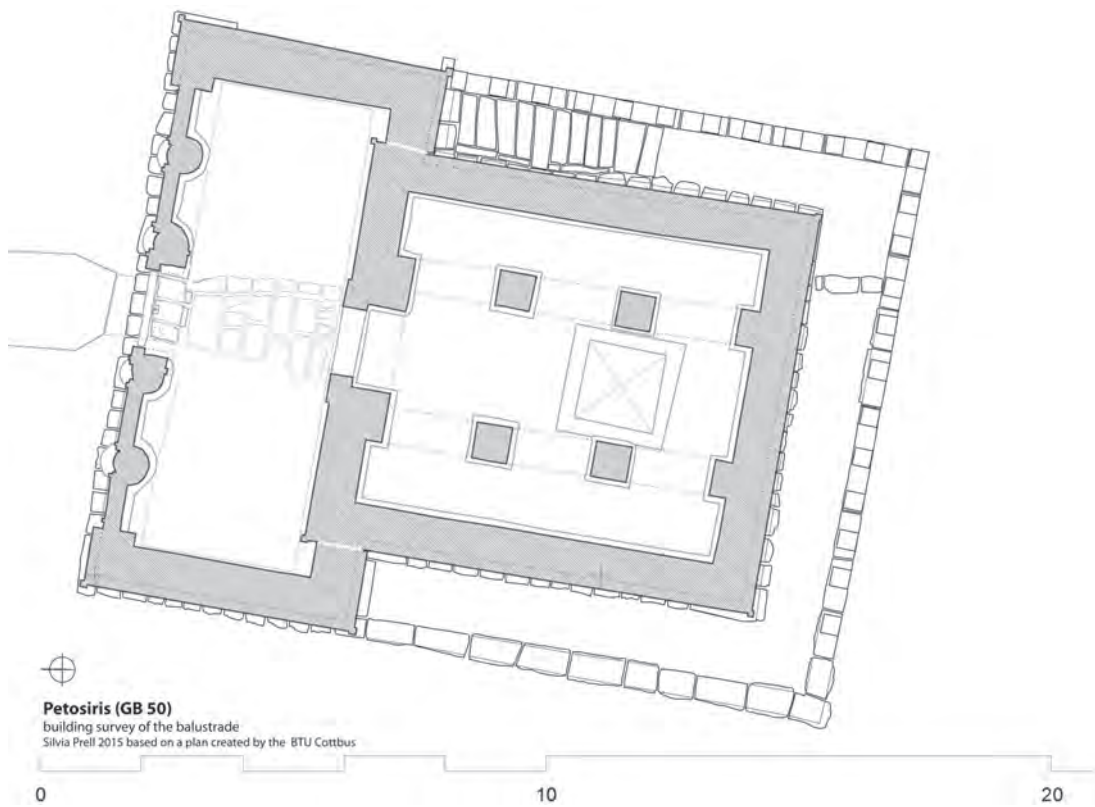
The foundation of the balustrade consists of local limestone blocks laid out in a U-shape around the naos, leaving an open space between them and the foundations of the temple tomb of about 110 cm (fig. 2 a–b). A new discovery in 2015, even if not unexpected, was the foundation of the balustrade in the west mentioned neither by Gustave Lefebvre in 1923/1924³ nor by Sami Gabra and his colleagues⁴. Furthermore, Paul Perdrizet emphasised in 1941 that the balustrade was absent in the west⁵.

Fig. 2 a: Plan of the balustrade and its foundations; 2015

Along the eastern wall of the naos of the tomb of Petosiris, eleven blocks of local limestone are left of the pavement between the naos and the balustrade. Another block of this pavement is preserved in the southeast, all of them joining the tomb with the balustrade (fig. 2 a–b). They are 100–120 cm long, 25–56 cm wide and 15 cm high¹². The top edge of the pavement lies 5 cm lower than the top

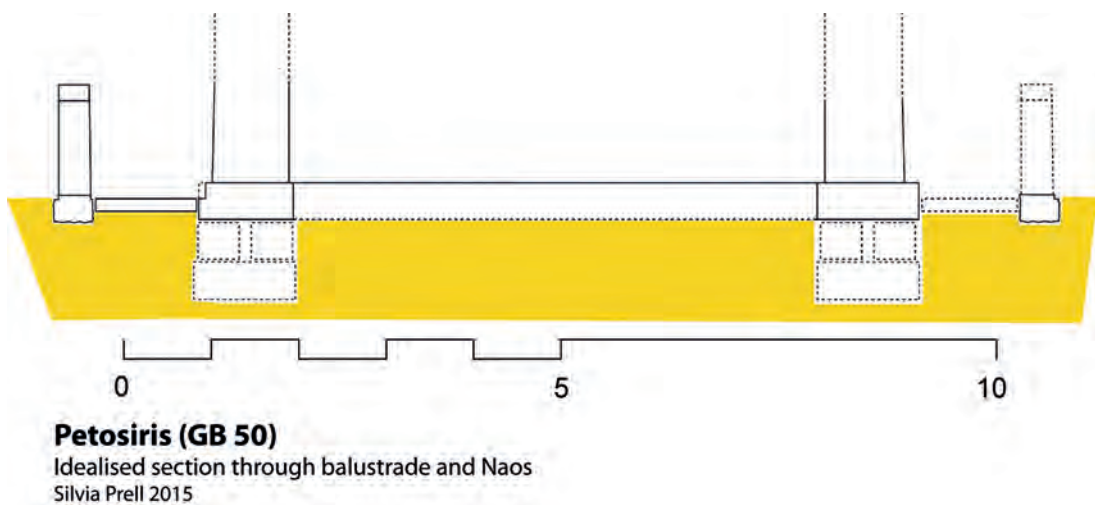
The blocks used for the foundation are generally 100–110 cm long; shorter ones, for example in the corners, measure at least 60 cm. All of the blocks are about 30 cm thick, as selectively checked at the inner south-western corner, with a levelled surface, plane and smoothed by charring. Only the uppermost parts (3–5 cm) of the sides of the blocks are worked more carefully, below they are very roughly shaped, because they were covered by sand and hence invisible. The smoothed surface is 35 cm wide, while the raw block is actually broader (fig. 2 b and 3).

Fig. 2 b: Idealised section through balustrade and tomb building; 2015

edge of the foundation blocks. The uppermost layer of the foundation of the naos, the euthynteria, however, has been chiselled off about 18 cm in certain places to match the height of the pavement (fig. 2 b and 5). Therefore, although the euthynteria seems to protrude only about 10–15 cm from the rising masonry of the tomb, it is actually wider. The length of the blocks of the euthynteria must have originally varied, because some of the blocks were not chopped off, while others protrude up to 20 cm further east below the pavement. Gaps in the pavement caused by the unevenness of the uppermost foundation layer were closed with smaller pieces or longer slabs (fig. 2 a and 5). As far as could be checked during cleaning, the

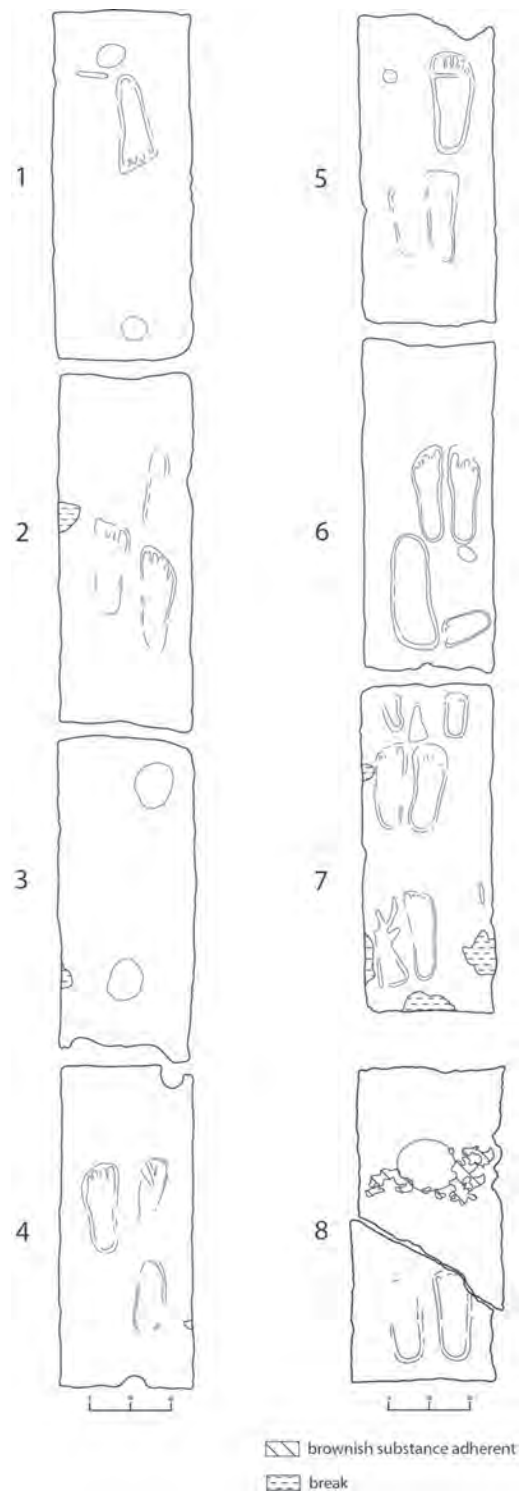
in length and 17 cm in thickness⁸. Seven of these slabs are still complete, two are broken in two pieces, and several further fragments have been found during cleaning the surroundings from sand. On seven of those slabs (six are complete and one is broken) the outline of a single foot or of a pair of feet is incised (fig. 4)⁹. They are of different sizes, and some smaller ones appear to belong to children. The toes are not always indicated; on a single foot on slab no. 5 a sandal seems to be indicated by a horizontal line incised directly below the toes. Most of the incised feet are pointing north, only two feet (slabs nos. 1 and 6) are pointing south¹⁰ and another foot (slab no. 6) is the only one pointing west. A pair of feet on slabs nos. 4 and 7 seems to be unfinished, which is suggested by the weak and incomplete incision of the second foot.

In addition, five slabs show offering moulds (fig. 4). Similar moulds appeared also at the euthyteria of GB 51 and the tomb of Padjkam (GB 54)¹¹. It is so far unclear, if those offering moulds were part of the funerary cult for Petosiris himself or if they belong to later burials that once surrounded the tomb.

Fig. 4: The seven complete slabs and one of the broken slabs once supported by the pillars, showing incised outlines of feet and offering moulds; 2015

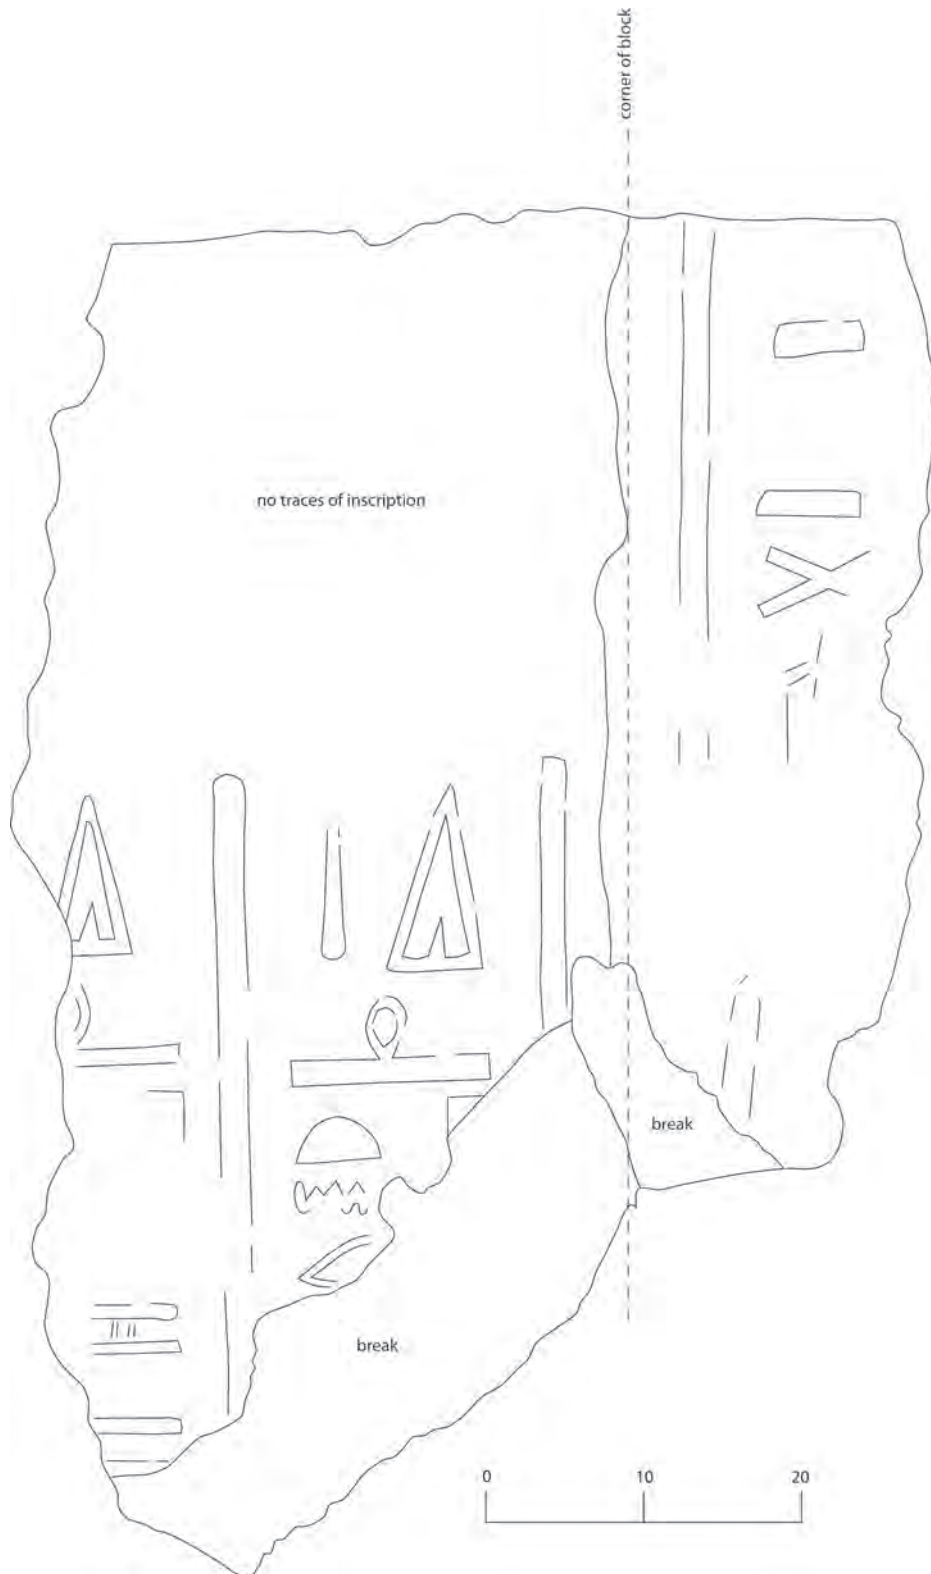
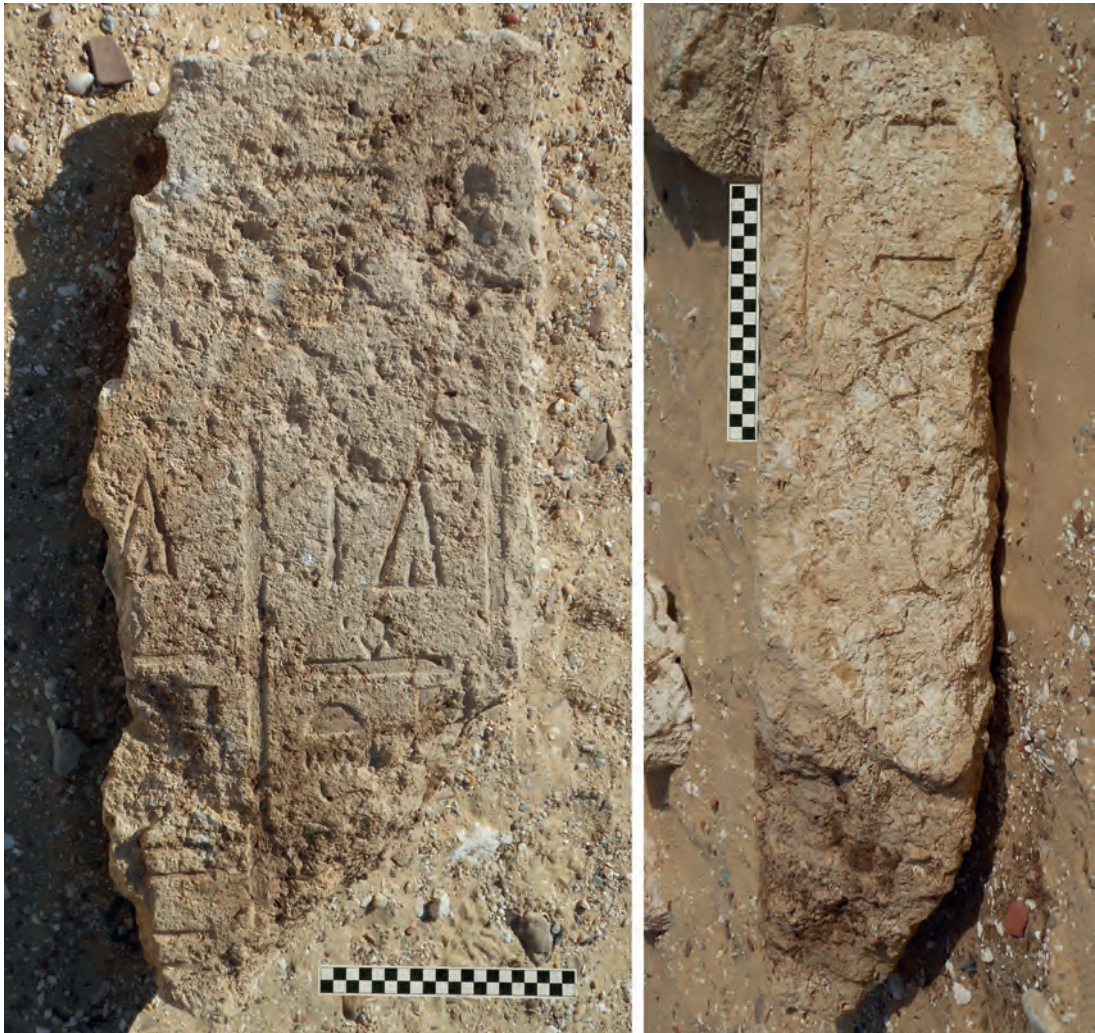
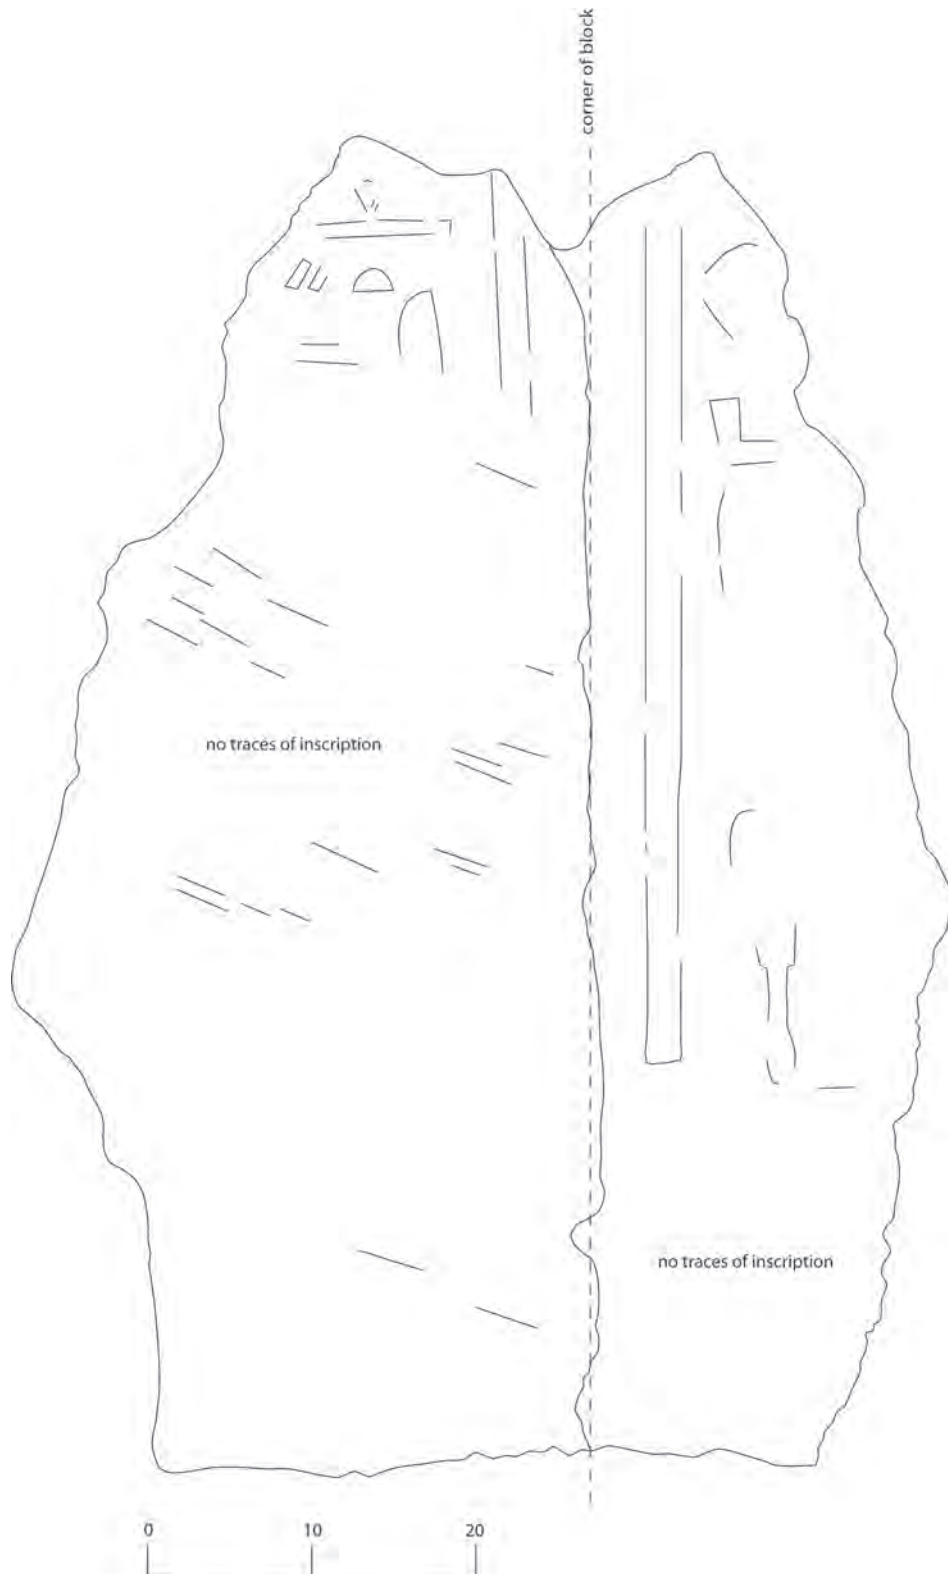
On the southern side, two fragmented blocks with hieroglyphic inscriptions in sunk relief were found among the scattered blocks. Most likely, they belong to the tomb of Petosiris (GB 50) and were part of the architraves once supporting the ceiling blocks. Both preserve an original edge of the block and bear traces of hieroglyphic inscriptions arranged in columns on two sides (fig. 7–9).

Fig. 7: Drawing of one block bearing a hieroglyphic inscription; 2015

Fig. 8: Photo of the same block bearing a hieroglyphic inscription; 2015

Fig. 9: Drawing of a second block bearing a hieroglyphic inscription; 2015

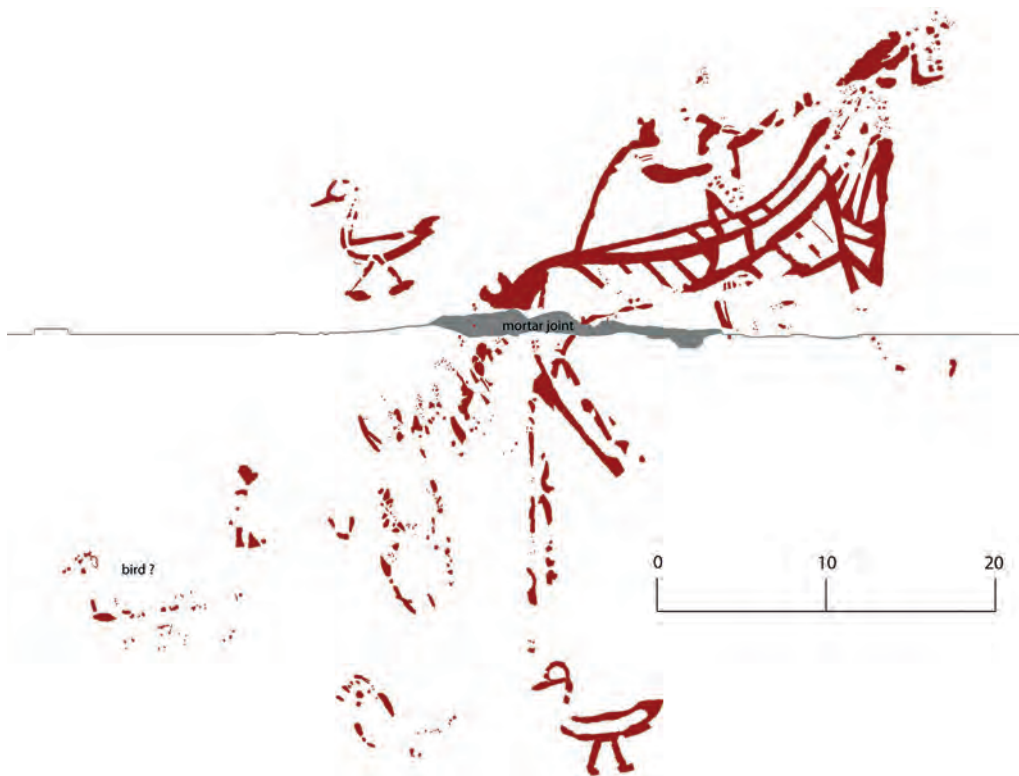
At the bottom part of the eastern wall near the corner of the hall, graffiti in red ink of a horseman (?) facing to the right and of at least two small birds facing to the left were found (fig. 10), which had not been documented by

Fig. 10: Graffito depicting a horseman (?) and some birds; 2015

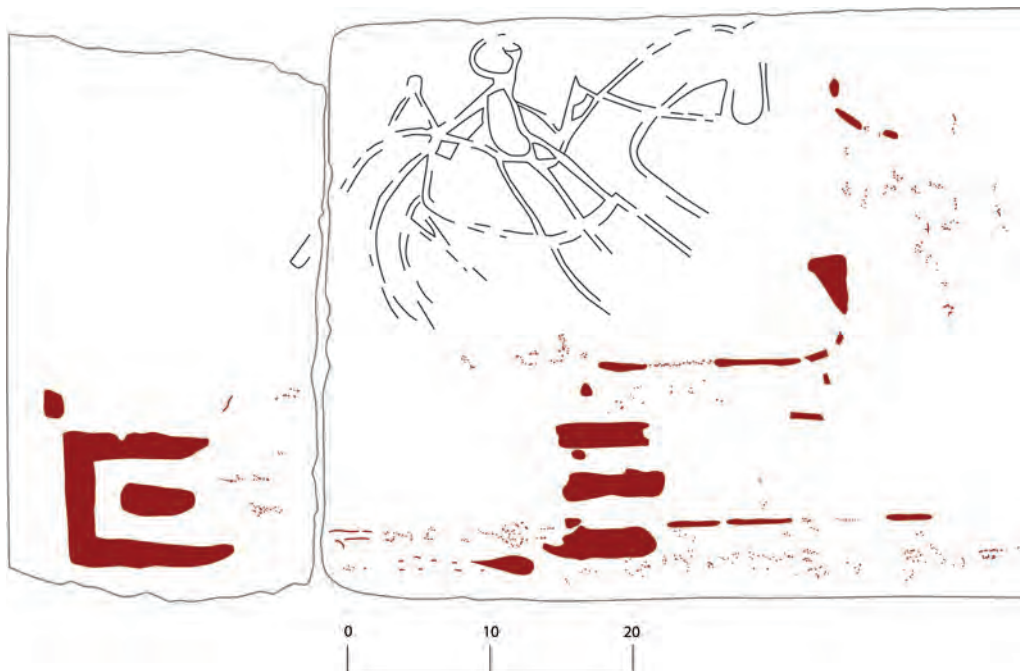
Lefebvre nor by Gabra. Another incised depiction of a horseman (fig. 11) and traces of red paint were found on the eastern wall of the pronaos of the temple tomb of Padjkam (GB 54)¹⁹.

Fig. 11: Temple tomb of Padjkam (GB 54), eastern wall of the pronaos, graffito depicting a horseman; 2015

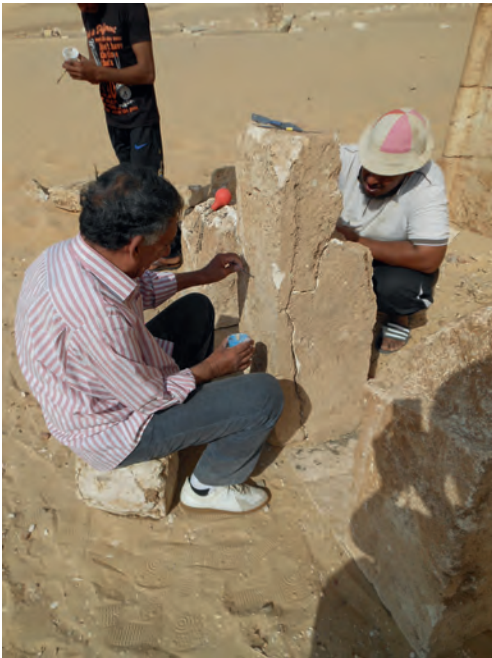
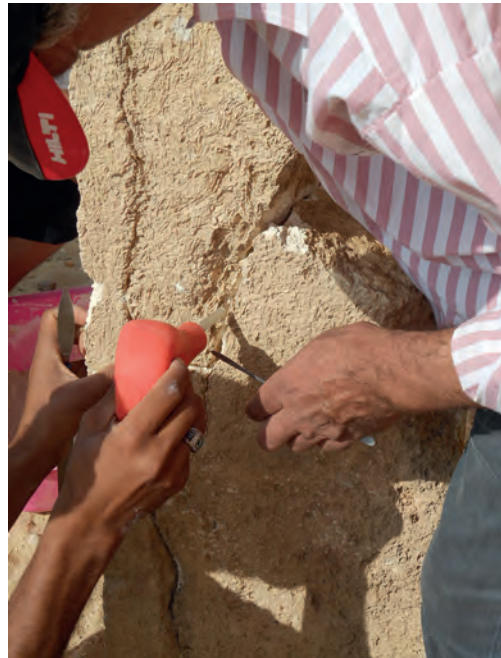
Fig. 12: Cleaning the surfaces of the stones; 2015

Fig. 13: Closing gaps with the help of lime mortar; 2015

- Cleaning the stone surfaces by spraying limewater onto the stones until they are saturated.
- Consolidating the natural stone with approved materials. Chipped and broken areas of the stones are repaired by patching the void with mortar (fig. 12–13) that consists of lime and sand (relation 1 : 2) with some drops of Primal (emulsion of paraloid). Ground particles of the same or similar stone are added to ensure a close colour match (fig. 14). This method is suitable when no stone for replacement is available or the void is less than 25 mm deep.
- Resurfacing the exfoliated surfaces.

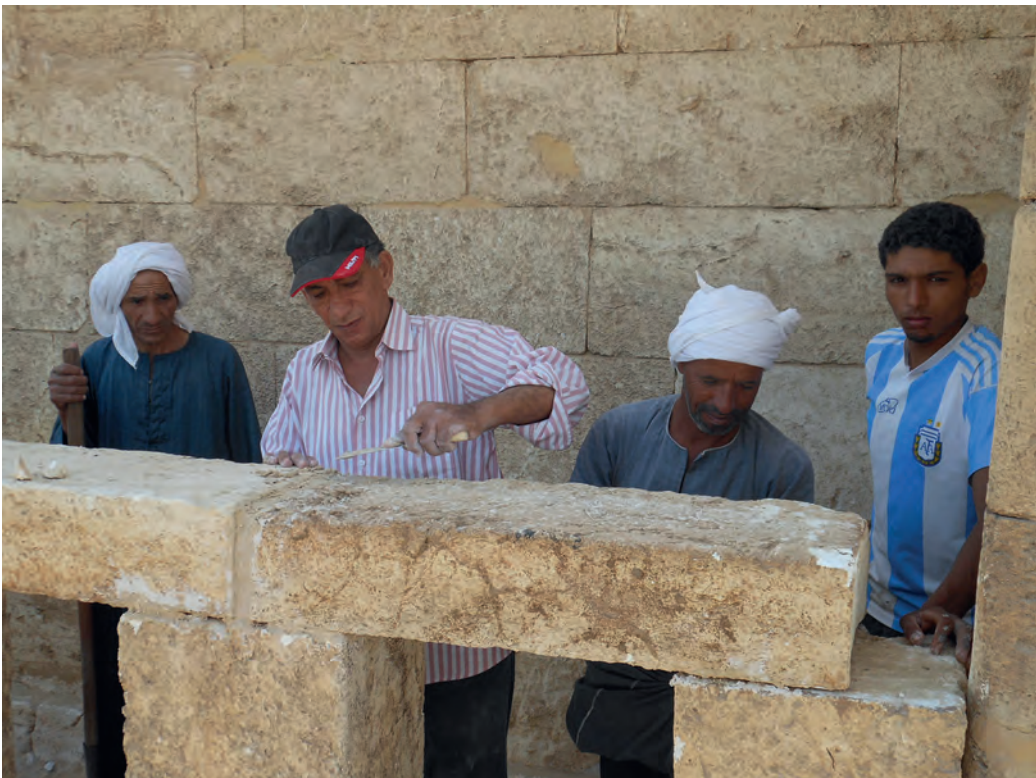
Fig. 14: Re-erection of balustrade with the help of lime mortar; 2015

In 2015, another restoration of the balustrade was accomplished using the following techniques:
