7 Site Management: Cleaning and Reconstruction of the Balustrade around the Naos of Petosiris (GB 50) – Some Observations

7.1 *The balustrade*

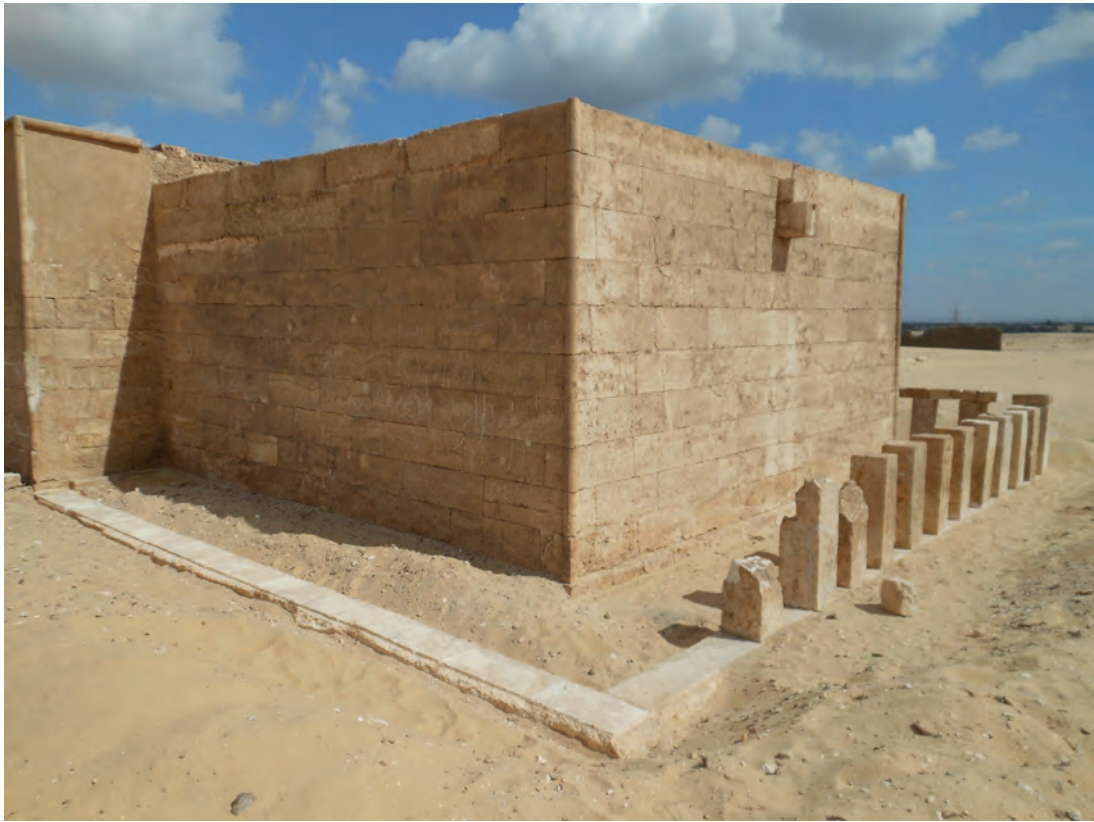
Fig. 3: The foundation of the balustrade in the west and south; 2015

The blocks used for the foundation are generally 100–110 cm long; shorter ones, for example in the corners, measure at least 60 cm. All of the blocks are about 30 cm thick, as selectively checked at the inner south-western corner, with a levelled surface, plane and smoothed by charring. Only the uppermost parts (3–5 cm) of the sides of the blocks are worked more carefully, below they are very roughly shaped, because they were covered by sand and hence invisible. The smoothed surface is 35 cm wide, while the raw block is actually broader (fig. 2 b and 3).

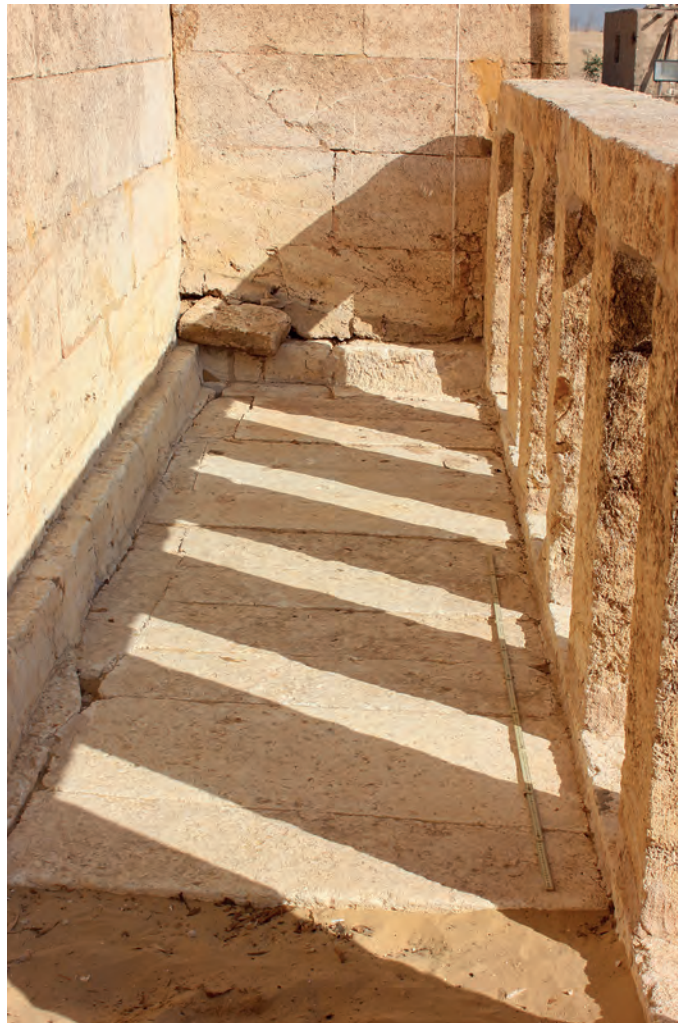
Fig. 5: Preserved pavement between naos and balustrade; 2015

edge of the foundation blocks. The uppermost layer of the foundation of the naos, the euthyneria, however, has been chiselled off about 18 cm in certain places to match the height of the pavement (fig. 2 b and 5). Therefore, although the euthyneria seems to protrude only about 10–15 cm from the rising masonry of the tomb, it is actually wider. The length of the blocks of the euthyneria must have originally varied, because some of the blocks were not chopped off, while others protrude up to 20 cm further east below the pavement. Gaps in the pavement caused by the unevenness of the uppermost foundation layer were closed with smaller pieces or longer slabs (fig. 2 a and 5). As far as could be checked during cleaning, the

Along the outside of the southern wall of the tomb of Petosiris and on parts of the eastern wall of the temple tomb, the remains of a floor consisting of lime mixed with pulverised red bricks and sand was discovered (fig. 5). This floor apparently belonged to a later phase, when in the Roman period ad-

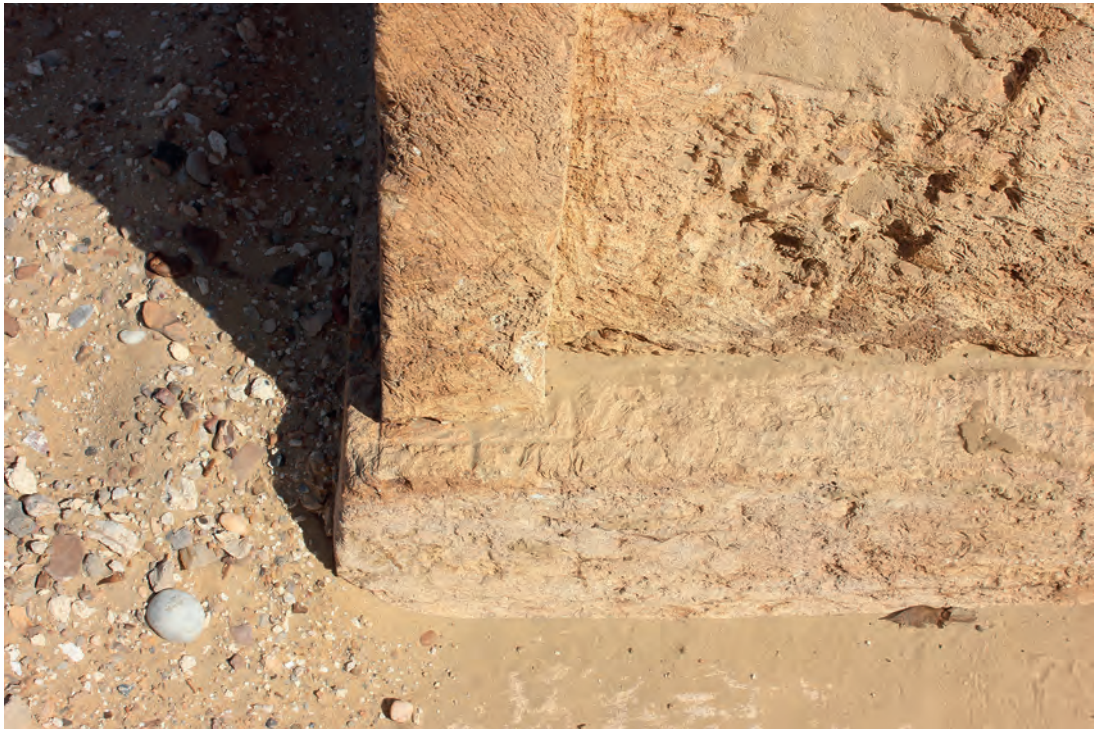
Fig. 6: Incision on top of the euthynteria indicating the future position of the round bar of the southwestern corner of the naos; 2015

While the euthynteria of the naos shows incised marks for the positioning of the blocks of the walls including the round bars at the corners (fig. 6)¹⁵, the uppermost foundation layer of the pronaos – although the joints of the ma-
